# Mechanical Stress Effects on 550 °C Hot Corrosion Propagation Rates in Precipitation Hardened Ni-Base Superalloys: CMSX-4, CM247LC DS and IN6203DS

**Keywords** High-temperature mechanical properties · Strengthening mechanisms

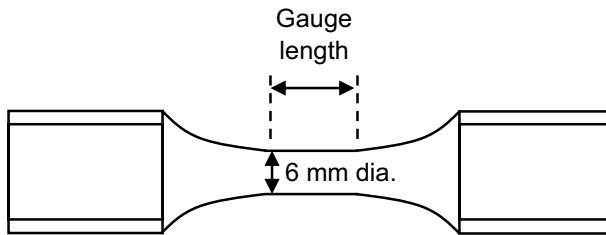
**Fig. 1** Schematic of fatigue specimen

The materials were single-point turned into plain fatigue specimens (Fig. 1) for the CF tests and 6 mm diameter cylindrical specimens (which represented the gauge diameter of the fatigue specimens) that were 10 mm long for hot corrosion exposures without the application of mechanical stress.

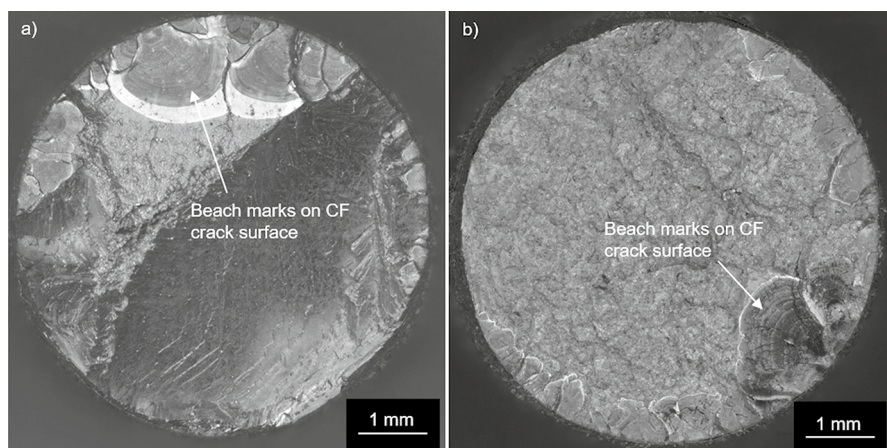
**Fig. 2** Optical microscopy images showing beach marks observed on the exposed CF crack faces after fracture occurred in **a** CMSX-4 (CF test completed 73 h with mean stress of 820 MPa) and **b** CM247LC DS (CF test completed 99 h with mean stress of 675 MPa)

Of the three materials subjected to the CF testing, only CMSX-4 and CM247LC DS experienced fractures. The respective fracture surfaces of these two materials indicated similar features in that multiple cracking had occurred which had propagated normal to the direction of mechanical stressing on the  $\langle 100 \rangle$  planes. The exposed crack surfaces revealed beach marks (Fig. 2) suggesting the cracking followed a start-stop-start process, but no evidence of fatigue striations could be found during the SEM examination. EDX mapping, on the unetched longitudinal sections, of the hot corrosion products within the CMSX-4 and CM247LC DS cracks that were remote from the final fracture, revealed an O [21] and S [20] embrittled phase (Fig. 3 shows an example from CMSX-4). Despite these similarities, a comparison of scatter plots showing the effect of mean stress against the duration of testing (Fig. 4) indicated that all three materials displayed different CF behaviours. All the CMSX-4 and CM247LC DS specimens had experienced cracking, which ultimately caused fractures in all but one of these superalloy specimens with significantly more scatter in the CM247LC DS results than in the CMSX-4 results. By contrast, the IN6203DS specimens successfully completed the 300 h of CF testing without showing any evidence of cracking. (For each material, the range of mechanical stress levels that were applied during the respective CF tests, included those which represented elastic stressing and others which represented plastic stressing. The identification of which CF test was performed with elastic or plastic stress though is not given in this paper to protect the sponsors' design data).

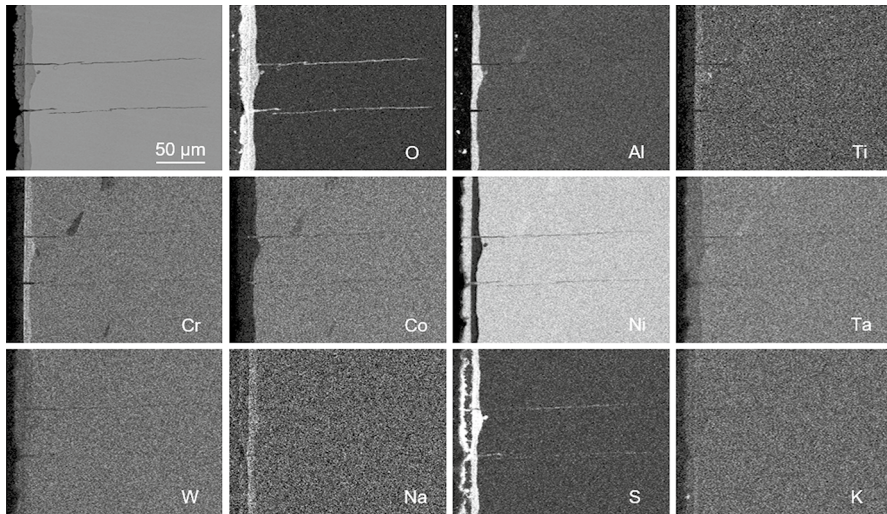
**Fig. 3** Example of EDX map from an unetched longitudinal section showing O and S penetration into CMSX-4 (CF test completed 73 h with mean stress of 820 MPa)

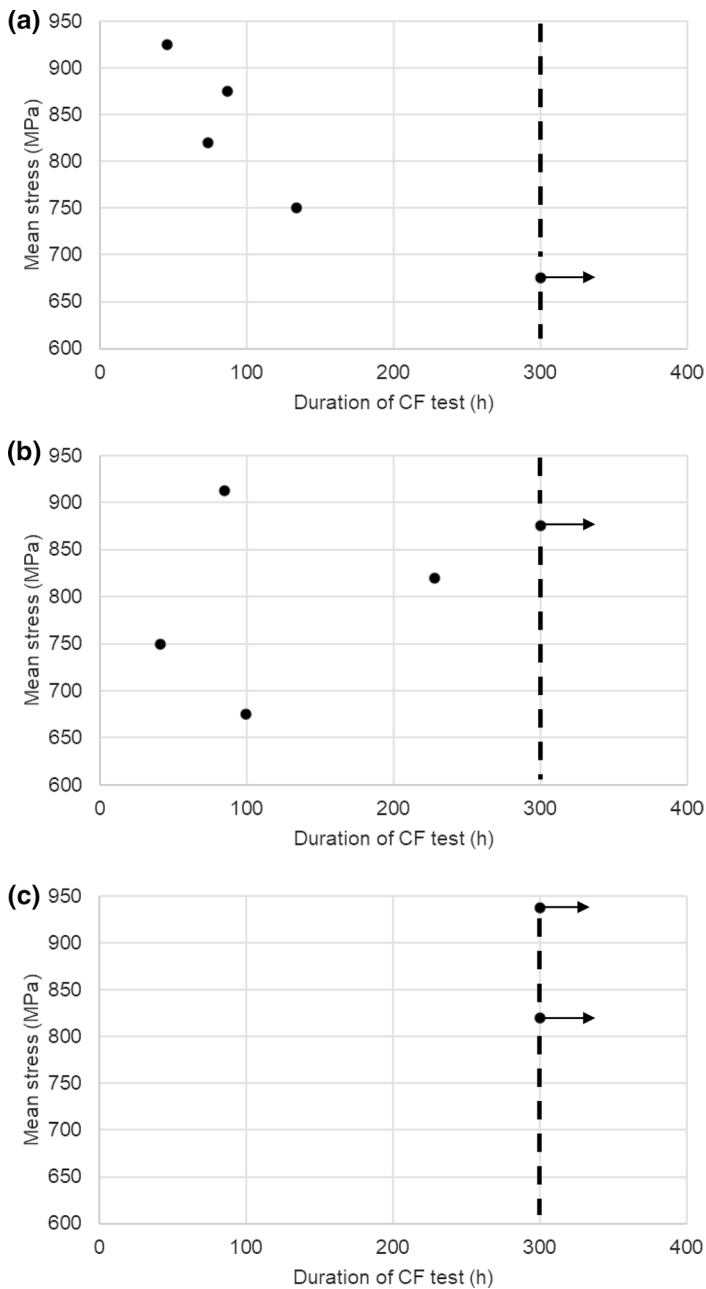
**Fig. 4** CF results of **a** CMSX-4, **b** CM247LC DS and **c** IN6203DS. Dashed lines represent end of test, arrows indicate runout specimens

surface-connected gamma-prime eutectic features were within the gauge length of the fatigue specimens. This randomness was therefore the most likely cause of the scatter observed within the CF results of CM247LC DS material (Fig. 4).

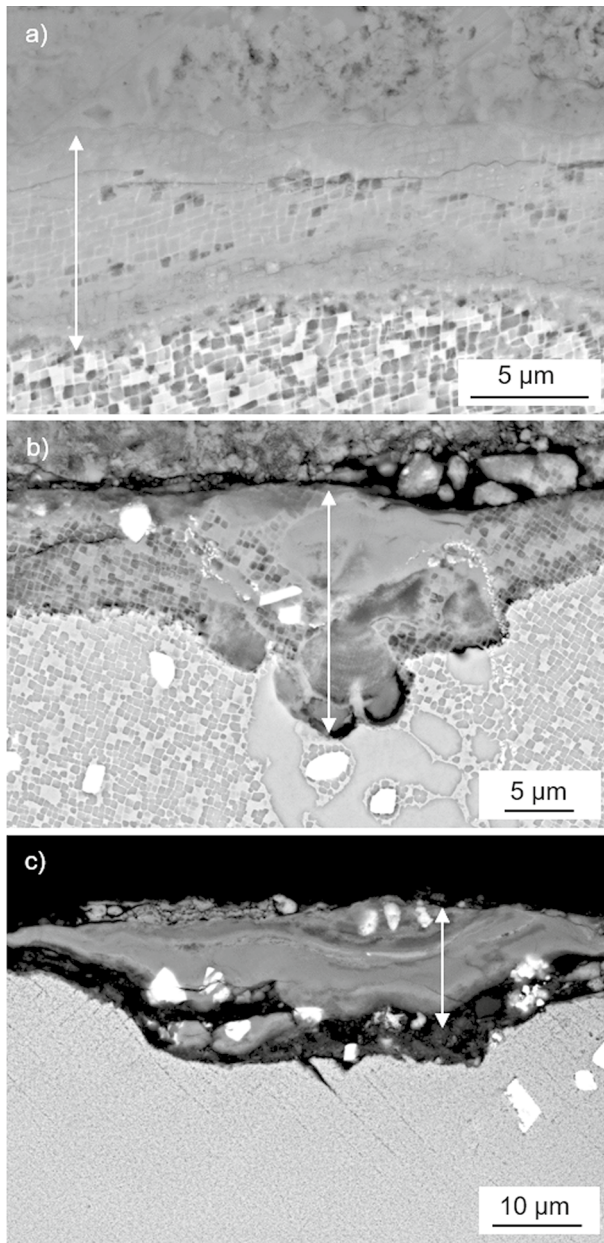
**Fig. 5** Back-scattered images of adherent intact scale on etched cross-sections of **a** CMSX-4 (CF test completed 86 h with mean stress of 875 MPa), **b** CM247LC DS (CF test completed 40 h with mean stress of 750 MPa) and **c** IN6203DS (CF test completed 300 h with mean stress of 938 MPa). Arrows indicate internal scale as defined by microstructural features (gamma prime and/or carbides)

To understand the different CF behaviours of the three materials, the polished and etched cross-sections of the specimens were used to investigate the effect of mechanical stress on the hot corrosion propagation rate. The back-scattered images obtained indicated the scale present consisted of an external and internal component (Fig. 5)

which were defined by the absence or presence of microstructural features such as the gamma-prime precipitates and/or carbides. Further to this, the images indicated the scale to be in various states of damage on each material, which was most likely caused by the high frequency of the CF tests. The damage observed included breakage/cracking of the internal scale in some areas suggesting spallation may have occurred, whilst other areas showed the internal scale to have minimal damage and were largely intact (as indicated in Fig. 5). The maximum observed depth of hot corrosion each fatigue specimen had experienced was therefore based on measuring the thickest intact internal scale from the respective back-scattered images. This allowed the mechanical stress influenced hot corrosion propagation rates, experienced during the CF testing, to be calculated as described in the Data analysis section.

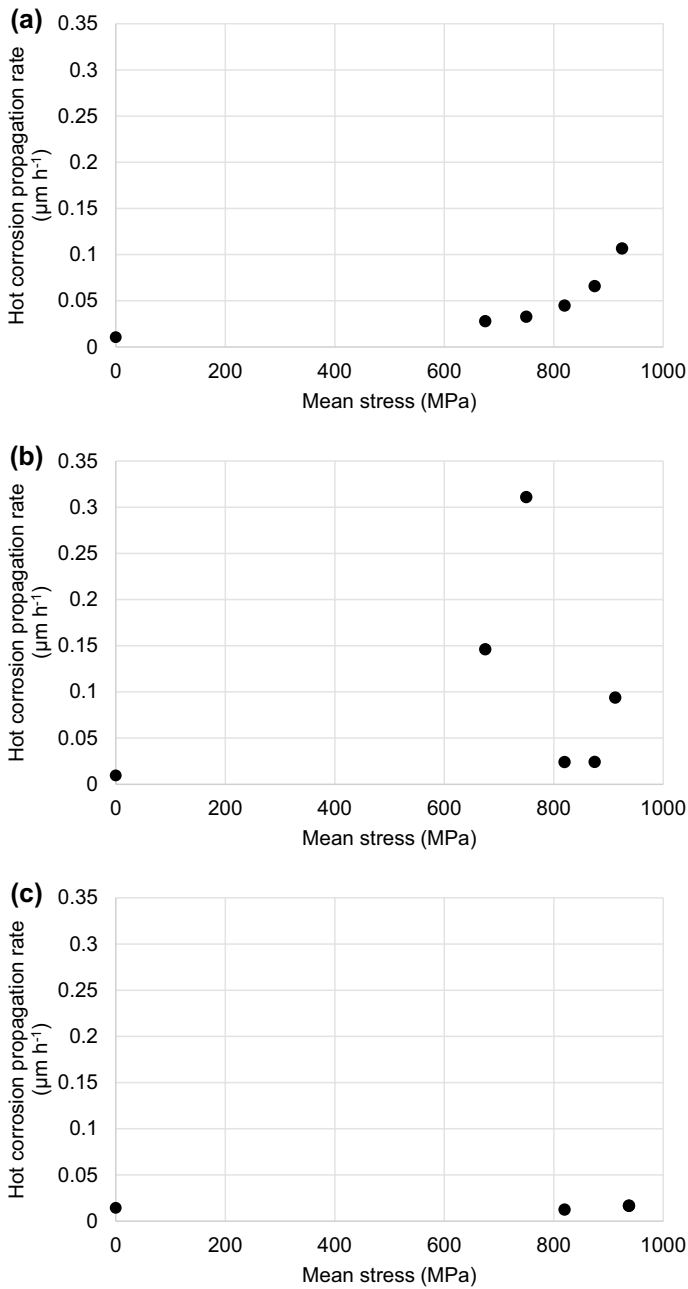
**Fig. 6** Mechanical stress effect on the maximum hot corrosion propagation rates of **a** CMSX-4, **b** CM247LC DS and **c** IN6203DS

Figure 6 shows a scatter plot for each material illustrating the effect that mechanical stress has on the calculated hot corrosion propagation rates. Also included in these plots is the respective hot corrosion propagation rate from the cylindrical specimens (obtained from the rate component in Eqs. 1–3) which were exposed without any mechanical stress being applied. No significant evidence of an increased hot corrosion propagation rate was found due to the mechanical stress applied during the CF testing of the IN6203DS material (rates of  $0.012$  and  $0.016 \mu\text{m h}^{-1}$  were calculated which were plausibly equal to the rate component of  $0.0142 (\mu\text{m h}^{-1})$  in Eq. 3). All fatigue specimens manufactured from CMSX-4 and CM247LC DS materials though did experience an increase in the hot corrosion propagation rate during the CF testing when compared with the respective rate components in Eqs. 1 and 2. In the case of CMSX-4, a predictable increasing trend in the calculated rate (rising from  $0.028$  to  $0.107 \mu\text{m h}^{-1}$ ) was associated with the mechanical stress which compared with the rate component of  $0.0105 (\mu\text{m h}^{-1})$  in Eq. 1. For CM247LC DS, the rates associated with the CF tests ranged between  $0.024$  to  $0.311 \mu\text{m h}^{-1}$  which were

all greater than the rate of  $0.000935 \text{ } (\mu\text{m h}^{-1})$  quoted in Eq. 2. However, no obvious trend was apparent for the mechanical stress-influenced CF hot corrosion propagation rates for CM247LC DS, and this appeared to be the cause of the greater degree of scatter in the CF results of this material.

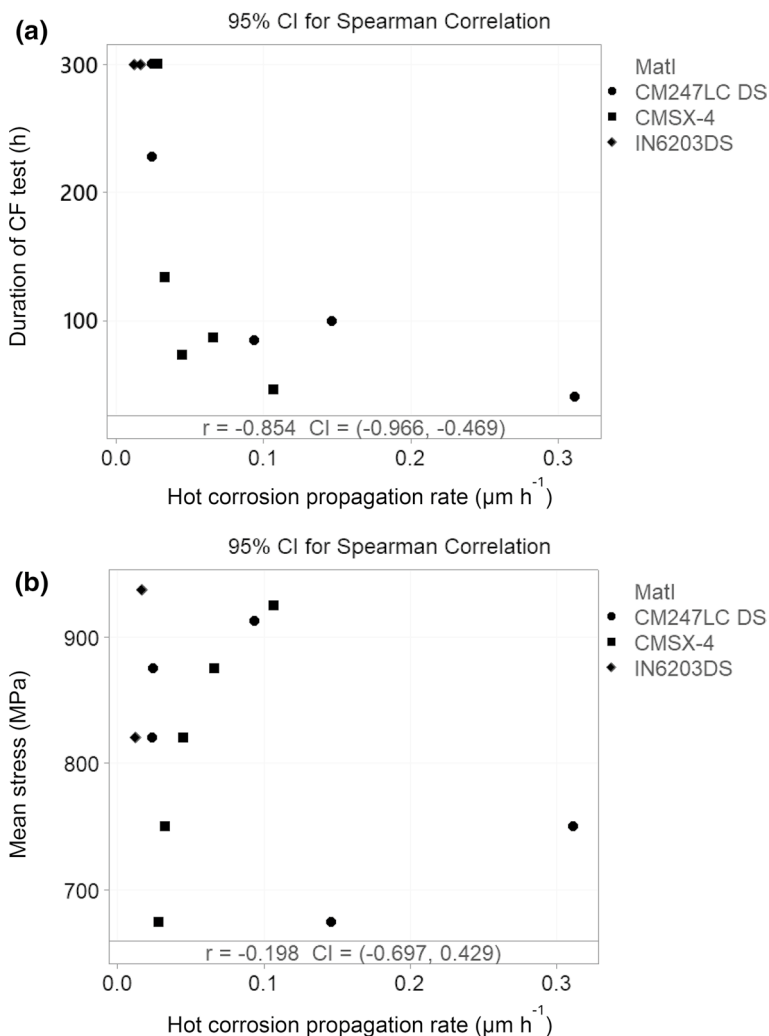
**Fig. 7** Spearman correlation analysis, performed with a 95% confidence interval, between **a** the hot corrosion propagation rate and the duration of the CF tests, and **b** the hot corrosion propagation rate and the mean stress the CF tests were performed at

After grouping the CF calculated hot corrosion propagation rates of all three materials into one group, a Spearman correlation test [22] was performed (using Minitab version 19 software) against the duration of the CF tests (Fig. 7a). This form of correlation test assesses monotonic relationships between two variables. An output is then provided which is used to determine if a non-linear relationship plausibly

exists between the two variables. The correlation coefficient obtained ( $-0.854$  with a 95% confidence interval of  $-0.966$  to  $-0.469$ ) indicated a strong relationship suggesting the hot corrosion propagation rate is an influential factor in the CF life of the three materials tested. However, it does not explain the cause of the increased rates.

Another Spearman correlation test was performed (Fig. 7b), but this time against the CF mean mechanical stress and the CF hot corrosion propagation rates. The correlation coefficient obtained ( $-0.198$  with a 95% confidence interval of  $-0.697$  to  $+0.429$ ) indicated little evidence for a relationship between these two variables. Although this may suggest that mechanical stress may not be an influential factor in the CF tests, it does not preclude it from interacting with another factor such as the microstructure.

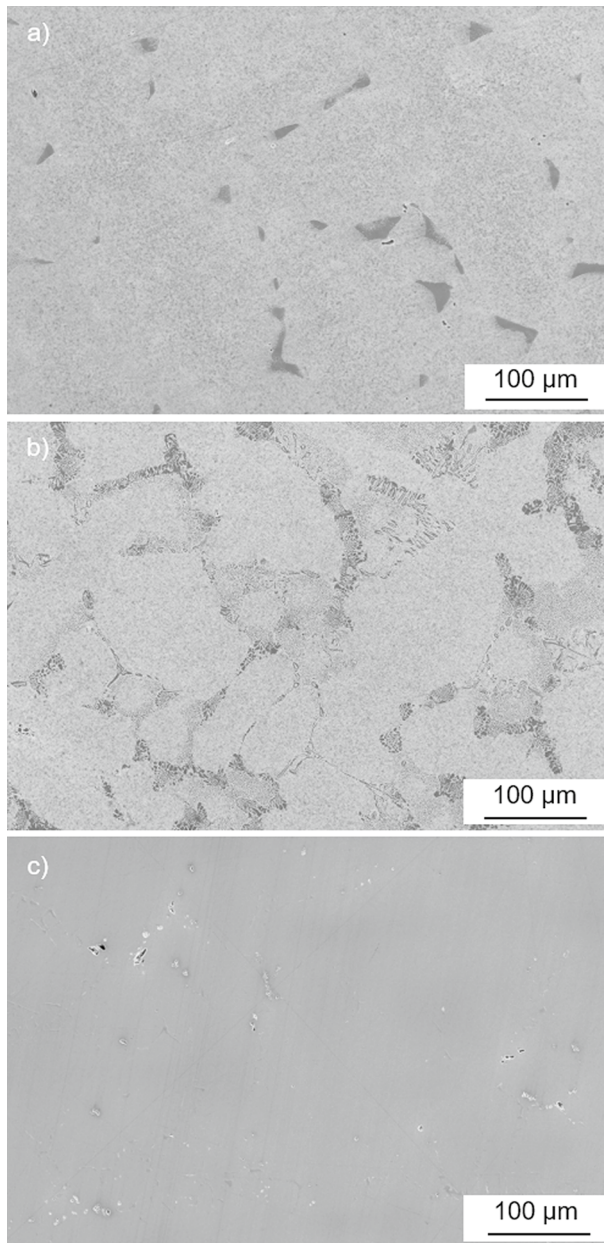
**Fig. 8** Secondary electron images of etched cross-sections showing the gamma prime eutectic in **(a)** CMSX-4 with a volume fraction, in image shown, of 3.0% (CF test completed 300 h with a mean stress of 675 MPa), **b** CM247LC DS with a volume fraction, in image shown, of 8.0% (CF test completed 300 h with a mean stress of 875 MPa) and **c** IN6203DS with a volume fraction, in image shown, of 0% (CF test completed 300 h with a mean stress of 820 MPa)

The interaction between the three factors (mechanical stress, gamma-prime precipitate volume fraction and gamma-prime eutectic volume fraction) may be more influential than the individual factors alone. Evidence of this possible interaction can be seen in Fig. 5b, which shows a localised region, associated with the gamma-prime of a surface connected eutectic region, that has experienced greater depths of hot corrosion attack than the adjacent areas.

Of the four factors which are proposed in the influential interaction that causes an increase in the hot corrosion propagation rates, and ultimately CF failures, the dominant factor(s) generally appear to be the ones associated with the microstructure. In the case of IN6203DS, the relatively low gamma-prime content (volume fractions of 27 and 0% for the precipitate and eutectic respectively) meant this material did not appear to experience any increase in the hot corrosion propagation rates with concurrent fatigue testing and was therefore immune to the influence of mechanical stress (under these conditions). CMSX-4 had gamma-prime volume fractions of 60 and 2.0% for the precipitate and eutectic (which appeared as isolated ‘clumps’) respectively. It seems that the eutectic volume fraction and distribution were insufficient to exert any major influence on the interaction allowing the magnitude of the mechanical stress to become the dominant factor in the predictable increase in the hot corrosion propagation rates as shown in Fig. 6. CM247LC DS had gamma-prime volume fractions of 52 and 6.8% respectively for the precipitate and eutectic (which tended to be a continuous distribution around the dendritic structure). In this case, it appears that the magnitude of stressing became less dominant and the eutectic volume fraction and distribution more influential within the interaction. This introduced a greater degree of randomness within the maximum hot corrosion propagation rates (Fig. 6), which was most likely due to how many and how deep the
